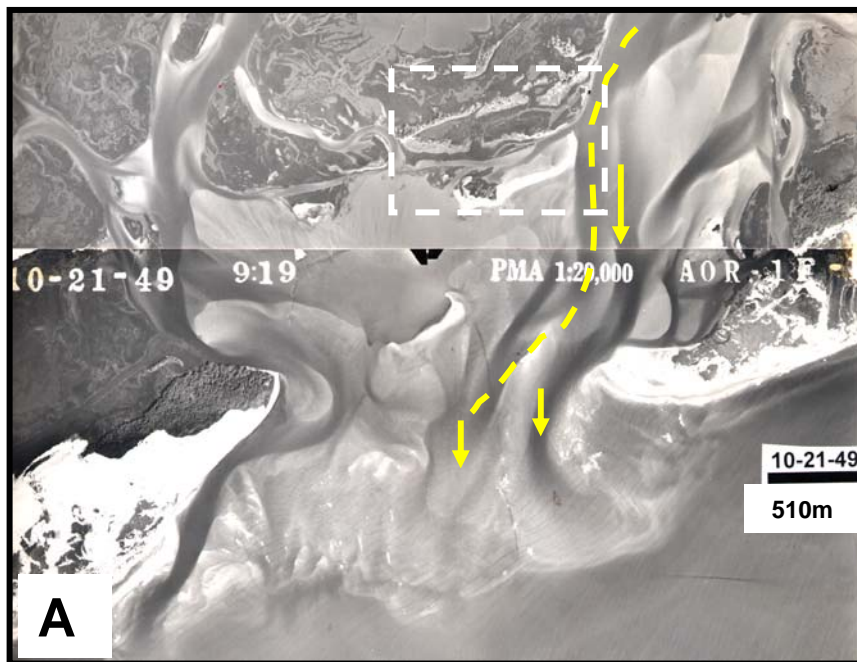
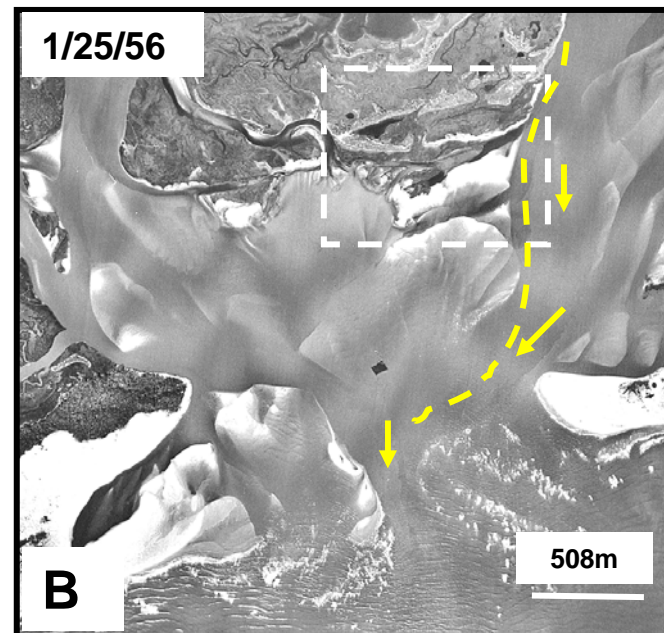
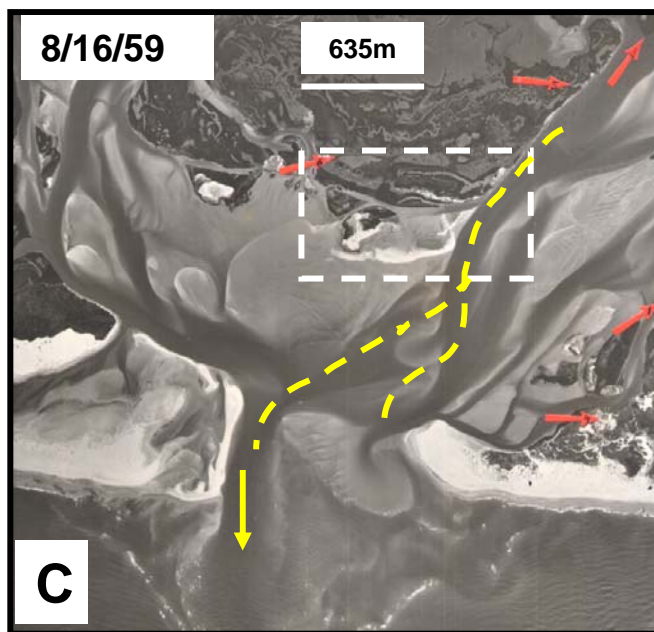
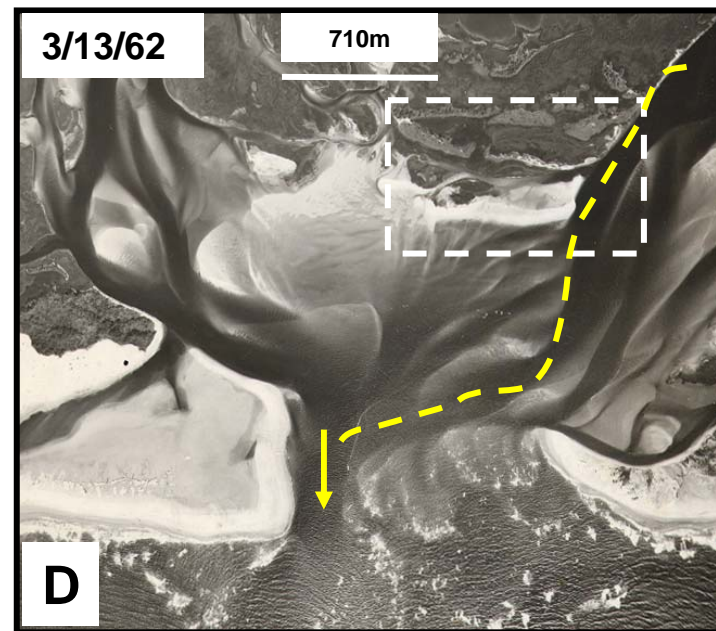
Figure 21. Historic aerial photographs (10/21/49- 3/13/62) depicting shoreline change along the Dudley Island shoreline and marsh complex. Dotted arrow delineates axis of the main ebb channel. Note the chronic washover “fan development” along much of the eastern frontal portion of the marsh complex.
